Contract #: 04-0120F4Cty: SF/ALA Rte: 80 PM: 13.2/13.9File #: 69.28**WELDING INSPECTION REPORT****Resident Engineer:** Pursell, Gary**Address:** 333 Burma Road**City:** Oakland, CA 94607**Report No:** WIR-013256**Date Inspected:** 01-Apr-2010**Project Name:** SAS Superstructure**OSM Arrival Time:** 700**Prime Contractor:** American Bridge/Fluor Enterprises, a JV**OSM Departure Time:** 1900**Contractor:** Zhenhua Port Machinery Company, Ltd (ZPMC), Changxing Island **Location:** Shanghai, China

WELDING INSPECTION REPORT

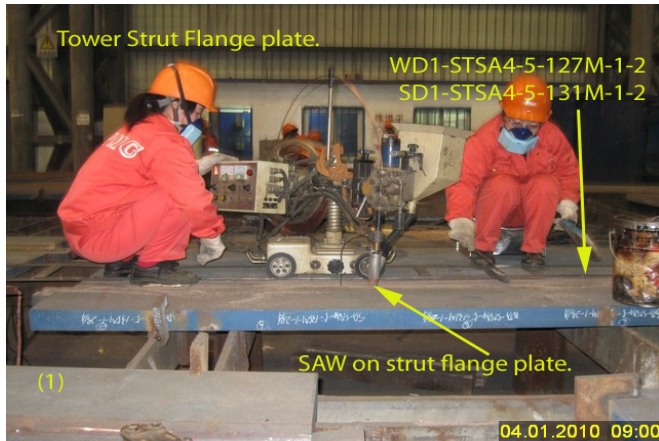
This QA Inspector observed ZPMC qualified welding personnel identified as 040699. Perform Submerged Arc Welding (SAW) on Tower flange plate. Joint identified as WD1-STSA4-5-127M-1-2, SD1-STSA4-5-131M-1-2. ZPMC QC Identified as Xu Jie, The welding parameters as measured using QC's calibrated instrument appeared to be in general compliance with WPS-B-T-4221-C-U3c-S-3. For more information see below attached photo No-1.

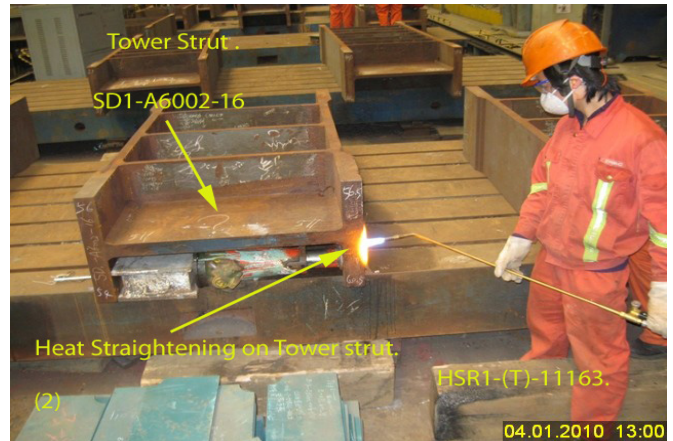
This QA Inspector observed during random Visual inspection found Heat Straightening on Tower strut. Strut identified as SD1-A6002-16. ZPMC QC identified as Mao Bin Bin with Heat straightening report, HSR1-(T)-11163. For more information see below attached photo No-2.
